**NSWCCD-65-TR-2005/04** March 2005

## **Preliminary Report on the SIDER Testing of Large-Scale Sandwich Panels**

Subj: SIDER INSPECTIONS OF LARGE-SCALE BALSA CORE PANELS

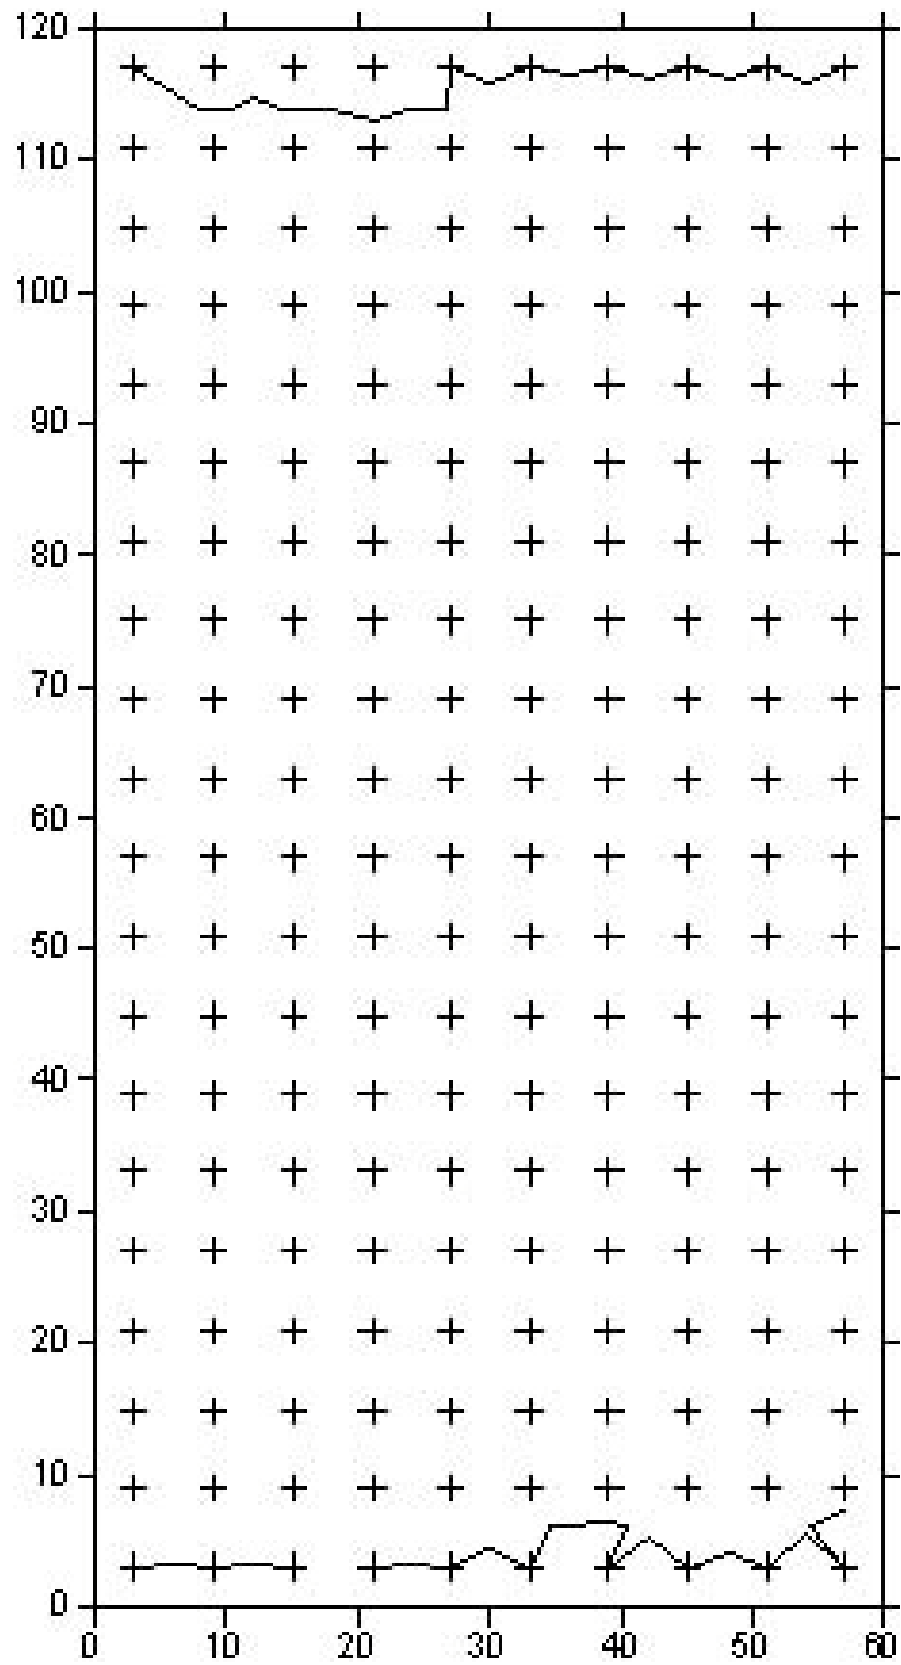
Figure 5. Part #1, Y-Direction Analysis

In this case, there are two small areas on panel 1 which show a difference from the rest of the panel. These areas are located near grid points 76 and 86, and grid points 192 and 193. For panel 2, there are many additional areas of concern which are too numerous to mention specifically here. It should be noted that with additional SIDER testing of more components, a baseline SIDER value could be established whereby only indications above this value are considered significant and indicative of manufacturing problems or damage.

Panel #1 showed minimal damage in two distinct areas of the panel. The rest of the panel appears damage free.

*The recommendation is to interrogate those locations only with an alternative technique such as ultrasonics. With additional alternate testing, it may be possible to identify the specific cause of the SIDER features, and whether they are of structural significance.*

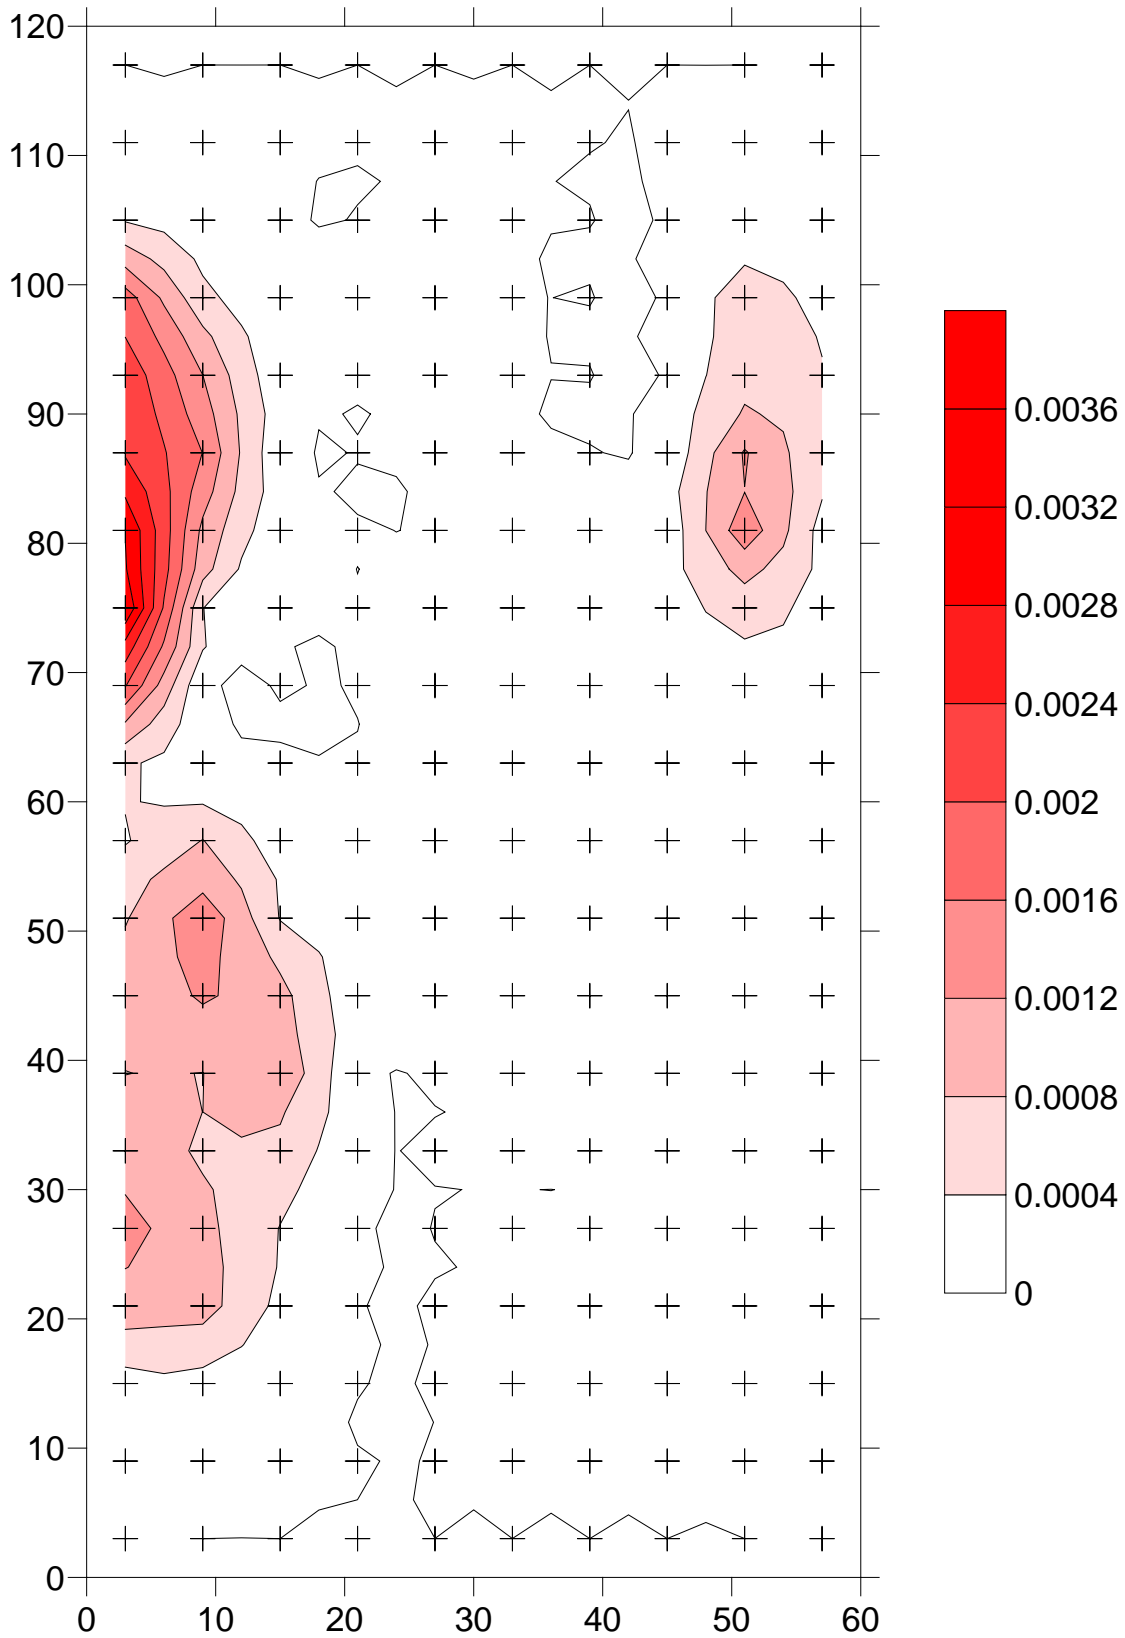
Figure 7. Part #2, Y-Direction Analysis

Due to the severe nature of the damage identified in Part #2, it was decided to replot the SIDER results using a different scale. In a single SIDER inspection, when a component demonstrates a feature which significantly dominates the plots, the original auto-scale plots can hide other less severe features that may still be of interest. Rescaling will often enable these less severe features to be identified. If multiple parts were to be inspected, a scaling could be established which would automatically indicate regions above the component norm. Figure 11 through Figure 14 repeat Figure 5 through Figure 8, but with a tenfold magnification. On these plots anything over an original value of 10% is set to a uniform maximum value.

Panel #2 had several large areas of significant damage. These areas cover virtually the entire plate.

*The main recommendation is to use ultrasonics to map out the boundaries of the major delaminations/debonds in order that they can be compared with the SIDER results. Additionally, if time permits, it may be appropriate to test the "SIDER-good" areas to ensure that they are, indeed, damage free.*
